# Retrofitting of Structures

By: Prof. Dr. Qaisar Ali  
Director EEC NWFP UET Peshawar

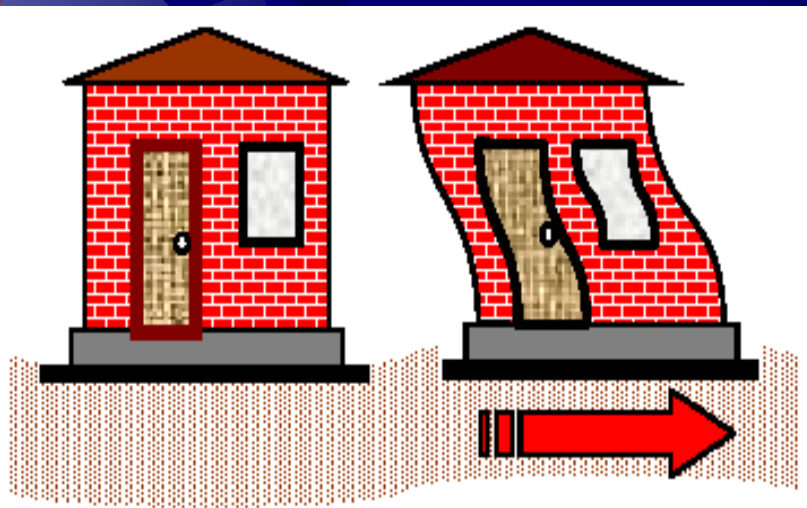
Figure 1: Effect of Inertia in a building when shaken at its base

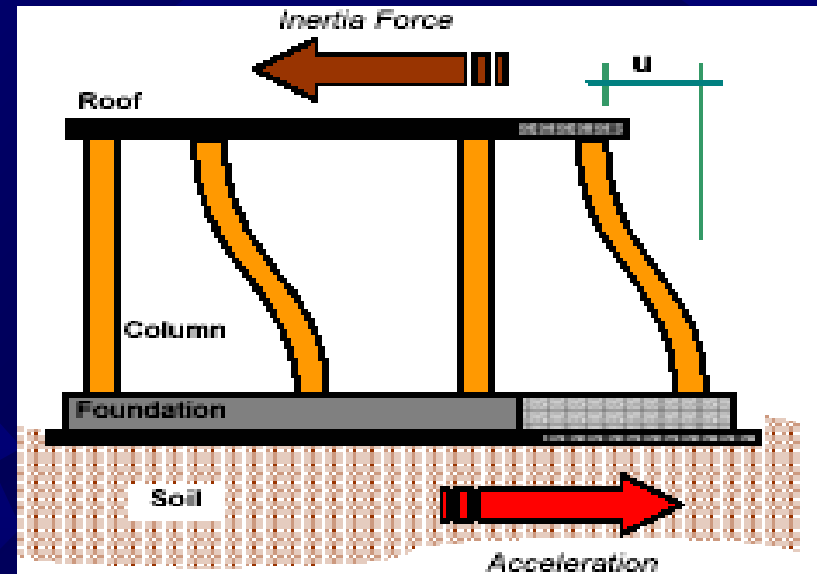
Figure 2: Inertia force and relative motion within a building

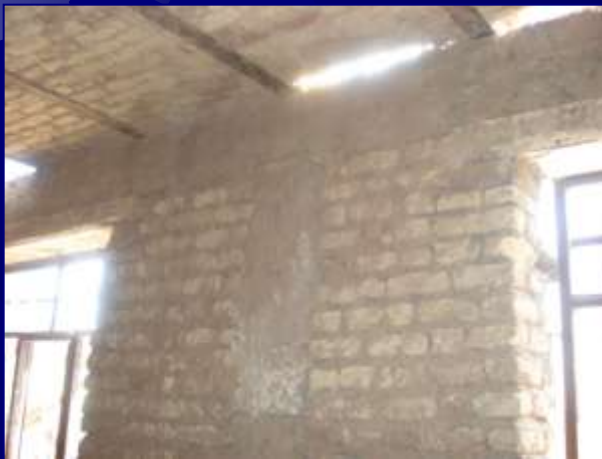
RC column, RC bond beam and flat arch

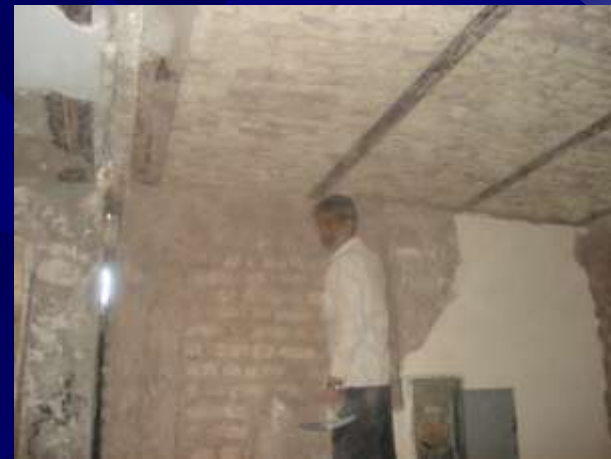
RC column, RC bond beam, flat arch and expansion joint

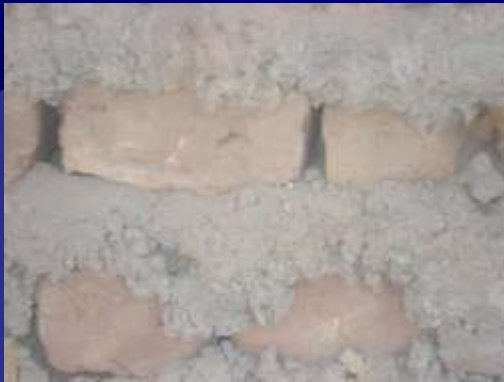
Poor quality masonry with too thick mortar joints

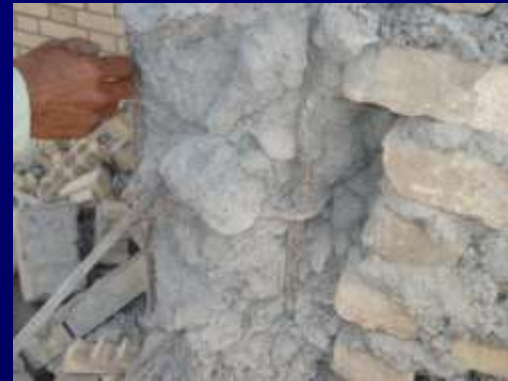
poor quality RC column with steel bars exposed

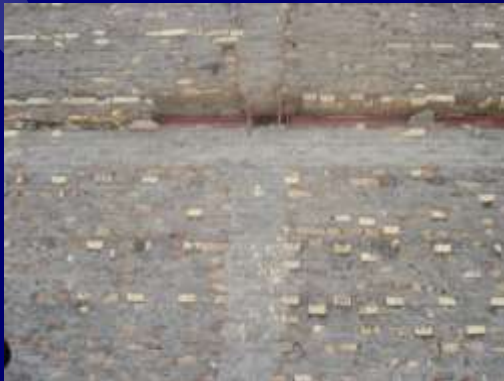
Poor quality masonry and columns bars exposed at floor level

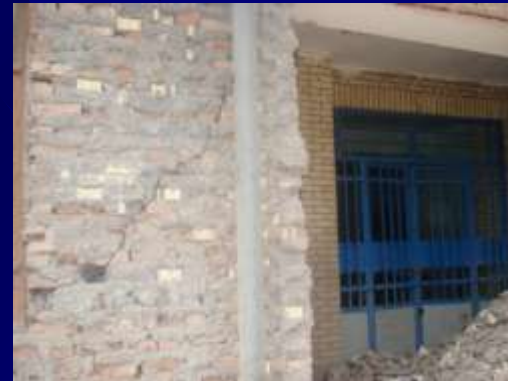
Diagonal cracks in masonry pier between two openings

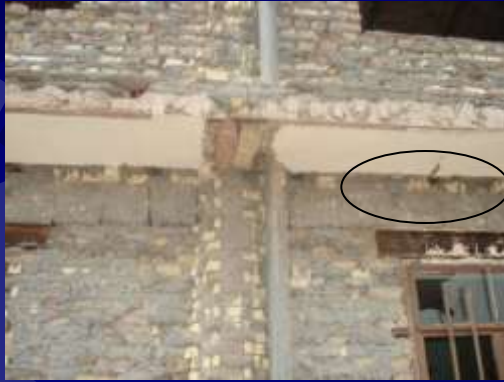
Steel I beam as lintel above window opening

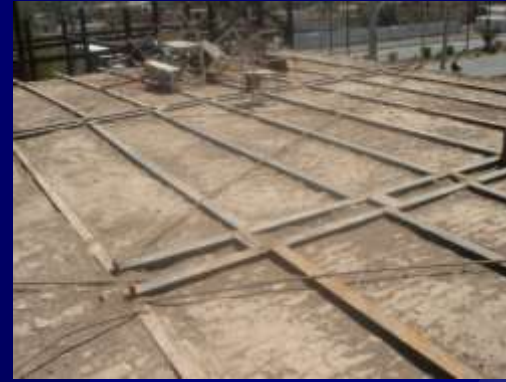
Steel I-beams with flat arch and bracing steel bars

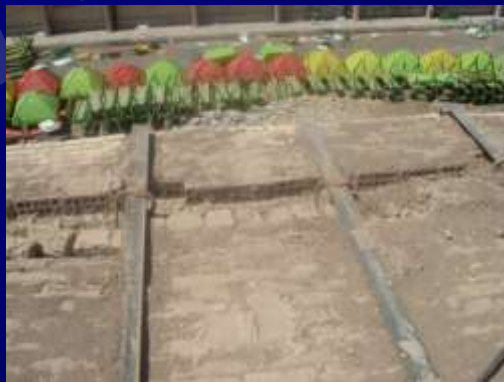
Anchor bolts for steel I-beams

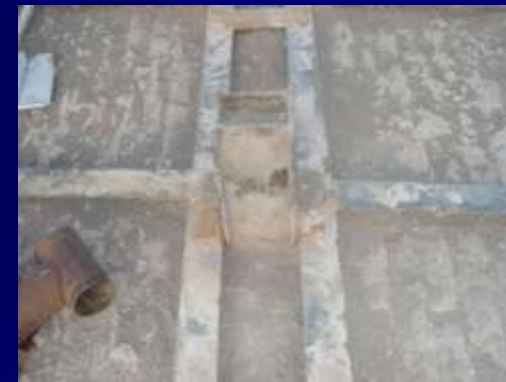
Steel I section column projecting from roof and connecting I-beams
